Details_CVSAN 2316_Alexander Park Vecinity

Alexander Park CCTV Photos

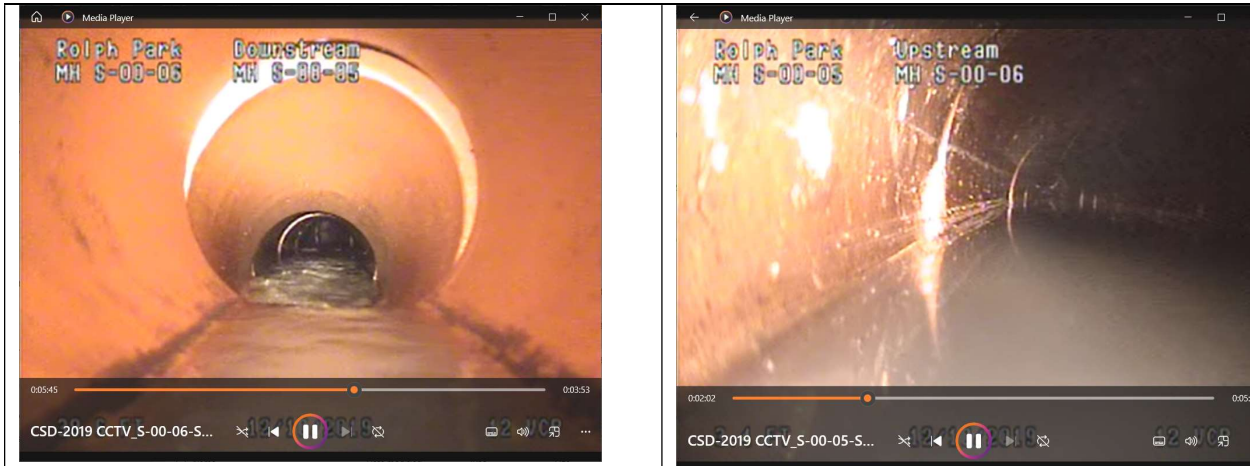
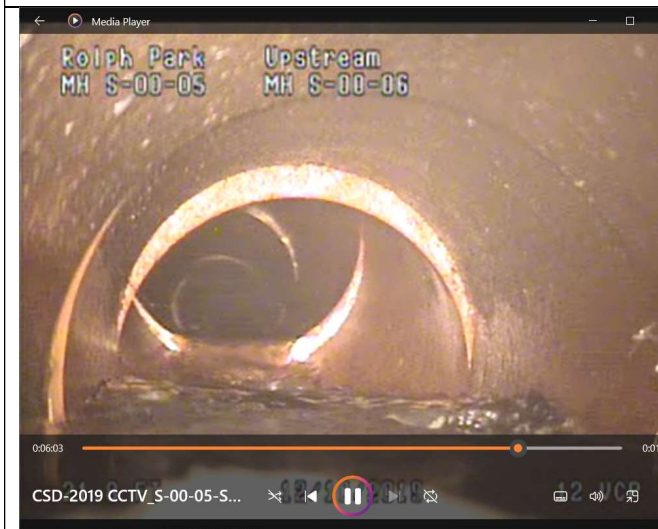
Pipe from 0' to 25' immediately upstream from Manhole S-00-05 has a sag, open trench is required to remediate this condition.

At 24' upstream from S-00-05, downslope offset, causes sag pool.
Above and left....at 38' downstream from SW-00-06, downslope offset –view of same offset and sag pool.
