754 Alhambra

CVSAN\_2304 Combination of two previous jobs....C&E ~262 ft total  
CVSAN\_C Project Details Full line replacement by pipe burst. 8" VCP, 125 ft MH-MH in sidewalk, steep incline.

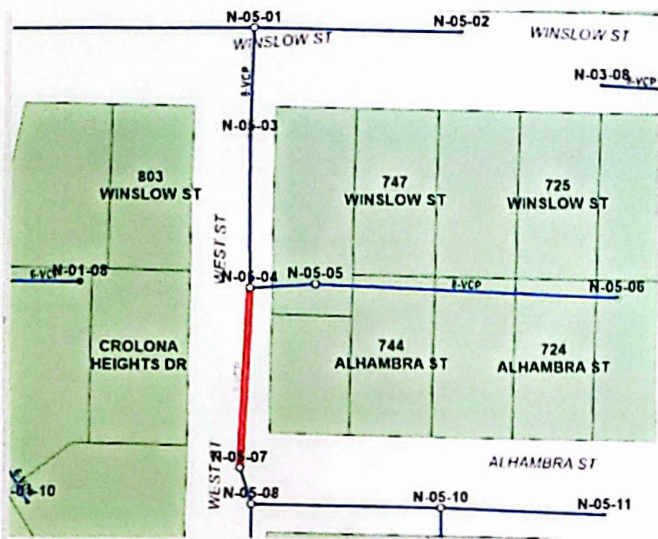
Previous suspected lateral problem at 754 Alhambra may be related. Lower MH 3.3', upper MH 4.5' invert depth

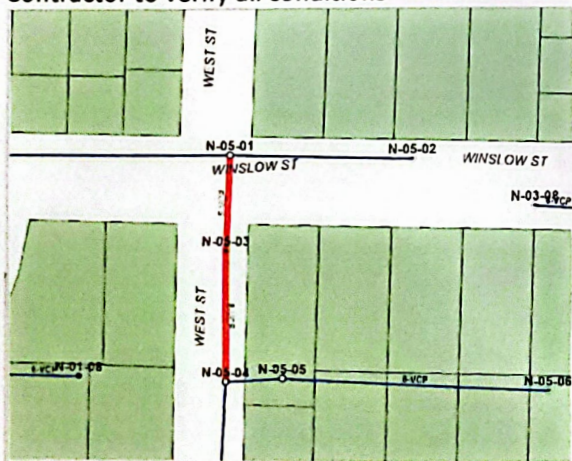
Details CVSan 23E 8" VCP, 60 ft from N-05-03 to N-05-01, RI to MH, Pipe burst. could Repair lower portion 15' but this segment has breakin tap and also is location of seep spring at West and Wnslow.

N-05-01 is 6' invert depth, N-05-03(rod inlet) is 4' invert depth, s

Note incorrect numbering on screenshot
